# NON-LINEAR ANALYSIS OF DAMAGE TO THE SHIH-KANG DAM DURING 1994 CHI-CHI EARTHQUAKE

## 1994年の集集地震における石岡ダム被害の非線形解析

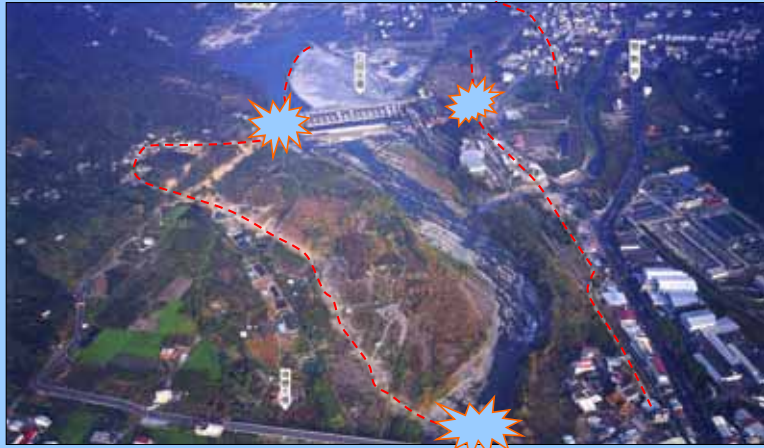
Figure 1. Damage on the infrastructure in the Shih-Kang area [1]

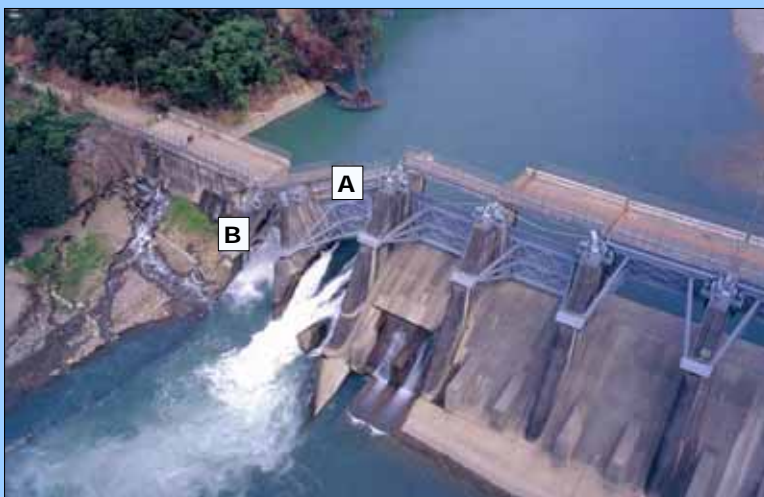
Figure 5 damage just above the fault

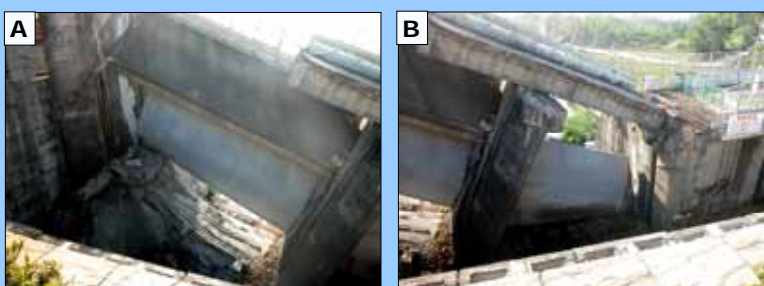
Figure 6 damage just above the fault after water draining

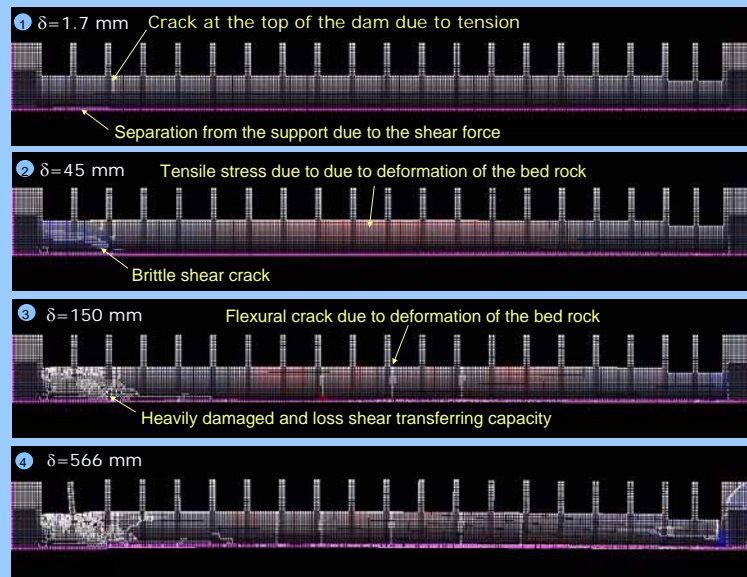
Figure 7 Crack pattern obtained from AEM
