### Experiment outline

In order to understand the dynamic response of masonry houses with and without PP-band mesh retrofitting and to compare crack patterns, failure behavior, and overall effectiveness of the retrofitting technique, shaking table tests were carried out. These tests were also intended to collect a dataset that will be used in the future to calibrate the numerical model.

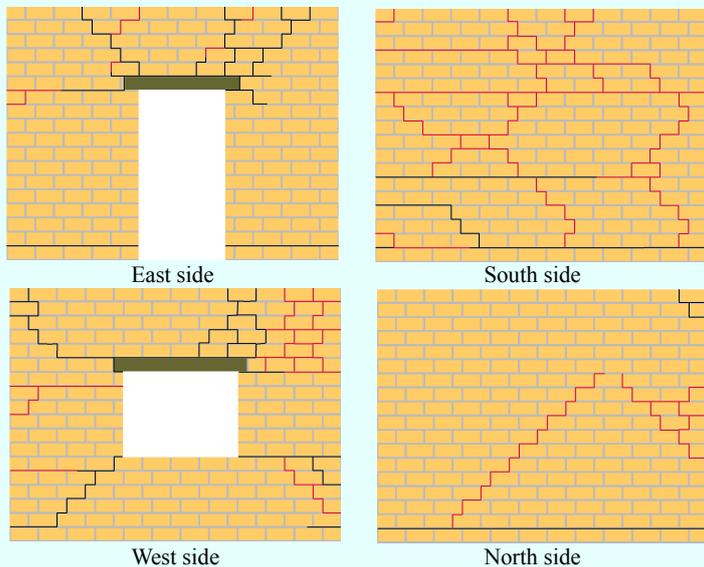
#### Non-retrofitted house

— Cracks observed after the 41<sup>st</sup> run, the collapse onset ( $a_{max}$ : 0.8g, f: 15Hz,  $d_{max}$ : 0.9mm)  
 — Cracks observed after the 46<sup>th</sup> run ( $a_{max}$ : 0.6g, f: 5Hz,  $d_{max}$ : 6.0mm)

Initial crack patterns for both models were similar. In the non-retrofitted model, cracks widened with each successive run. This finally led to the structure collapse. On the other hand, in the retrofitted model, new cracks appear in each run, thus, extensive cracking was observed. Although the PP-band mesh kept the structure integral during the shaking, it allowed the sliding of the bricks along these cracks. This constituted an important mechanism of energy dissipation.

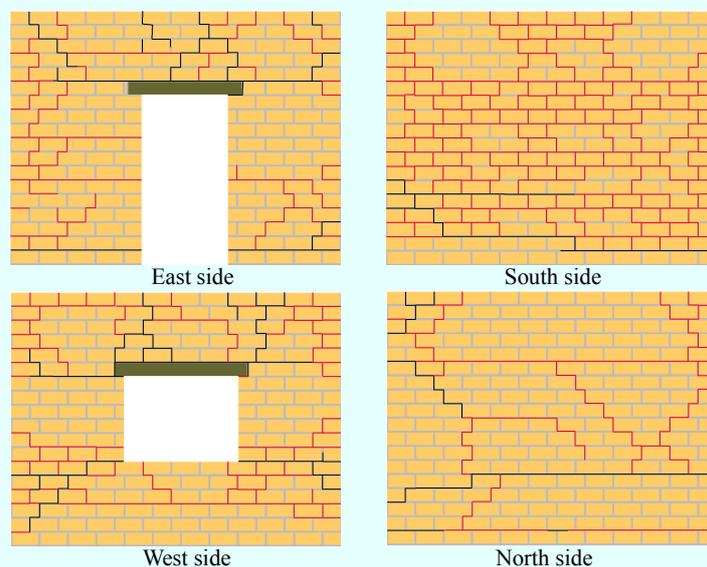
#### Retrofitted house

— Cracks observed after the 41<sup>th</sup> run ( $a_{max}$ : 0.8g, f: 15Hz,  $d_{max}$ : 0.9mm)  
 — Cracks observed after the 60<sup>th</sup> run ( $a_{max}$ : 0.6g, f: 2Hz,  $d_{max}$ : 37.3mm)

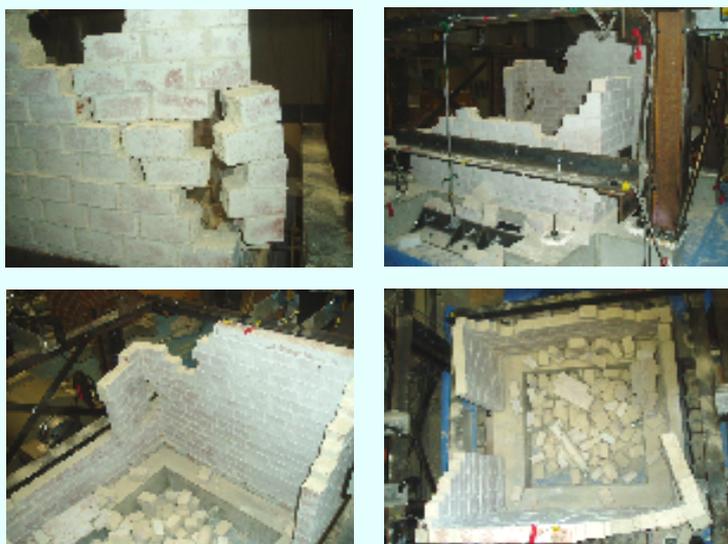
**Collapse of non-retrofitted house after the 46<sup>th</sup> run**  
 ( $a_{max}$ : 0.6g; f: 5Hz,  $d_{max}$ : 6mm)

Partial collapse of the non-retrofitted house occurred in the 44<sup>th</sup> run ( $a_{max}$ : 0.8g, f: 10Hz,  $d_{max}$ : 2.0mm). The building totally collapsed in the 46<sup>th</sup> run ( $a_{max}$ : 0.6g, f: 5Hz,  $d_{max}$ : 6.0mm)

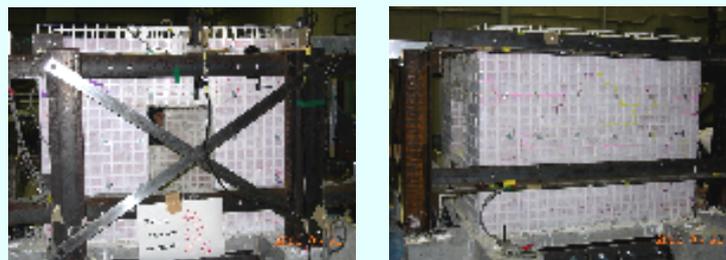
**Retrofitted house after the 46<sup>th</sup> run.** Although it was slightly more cracked than the non-retrofitted house, it did not collapse.

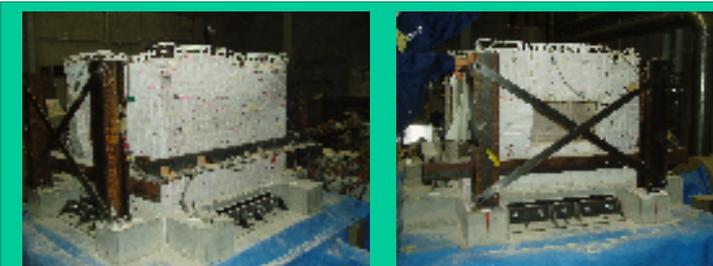
The retrofitted house was shaken until the 61<sup>th</sup> run ( $a_{max}$ : 0.8g, f: 2Hz,  $d_{max}$ : 49.7mm). The structure exhibited remarkable deformations because of the large number of failed mortar joints. Nevertheless, the PP-band mesh provided confinement and held the disintegrated elements together preventing the collapse.
