Objective

To investigate applicability and effect of PP-band retrofit method to double storey masonry houses with RC roof by shake table test using scaled model.

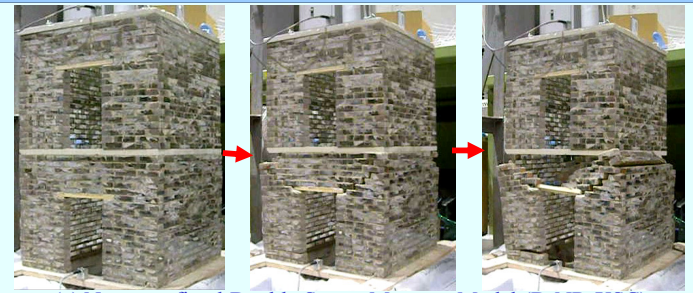
(a) Non-retrofitted Double Storey Masonry Model (D-NR-XSC)

The above photos show the non-retrofitted and retrofitted double storey masonry house models from start to end of the test. **In the non-retrofitted case, the first storey walls showed shear cracks as well as bending cracks along with sliding of the second storey as one unit. While in the retrofitted case, although PP-band mesh influence was not observed before initial cracking, after this occurred, crack propagation was prevented due to PP-band and the whole model behaved as one unit under the dynamic load.**

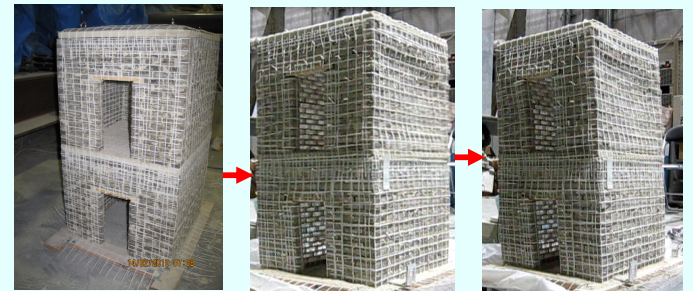
(b) PP-band Retrofitted Double Storey Masonry Model (D-R-SC)

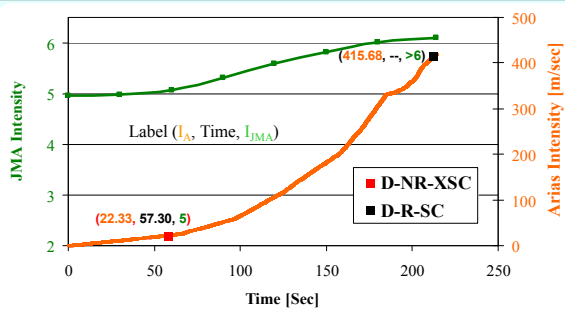
Comparison of Seismic Capacity

Non-retrofitted model performed well and it did not show any considerable damage until the input acceleration was below 141 gal [$I_{MA} < 5$]. But when the acceleration was raised to 300 gal, the specimen collapsed suddenly. The Arias Intensity (I_A) at collapse point was recorded 22.33m/sec. On the other hand, retrofitted model behaved as one unit through out the shake table test and it did not collapse even a strong input motion of 1,200 gal was applied and Arias Intensity (I_A) was 415.88m/sec. **PP-band retrofitted masonry model showed almost 4 and 18 times greater seismic capacity than the non-retrofitted one in terms of ground acceleration and arias intensity, respectively.**

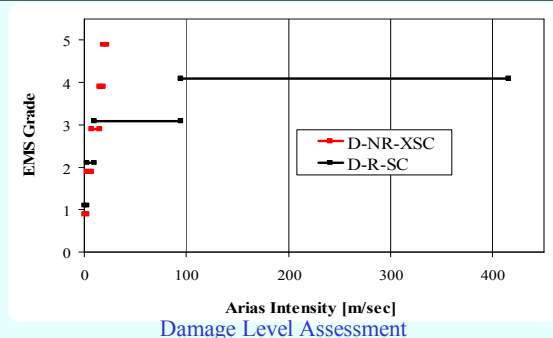
Damage Level Assessment

The above graph shows the damage levels of the masonry house models using European Macro-seismic Scale [EMS] Grades. Both models, non-retrofitted and retrofitted, showed almost the same damage level before occurrence of considerable cracks but after that PP-band became effective in retrofitted model and complete collapse of structure was thwarted. It is important to note that double storey masonry model did not collapse completely and minor distortion of walls occurred at an input acceleration of 1,200gal. **Maximum lateral displacement recorded at the second storey slab level was 8.31 and 41.88mm, for non-retrofitted and retrofitted models, respectively.**
