NUMERICAL MODELLING OF FAULTS USING APPLIED ELEMENT METHOD

応用要素法(AEM)を用いた縦ずれ断層の2次元静的モデリング

A new application to Applied Element Method (AEM) is formulated to study the behavior of the fault rupture zone. In this study, we investigated the influence of reverse dip-slip fault on the rupture surface and its location.

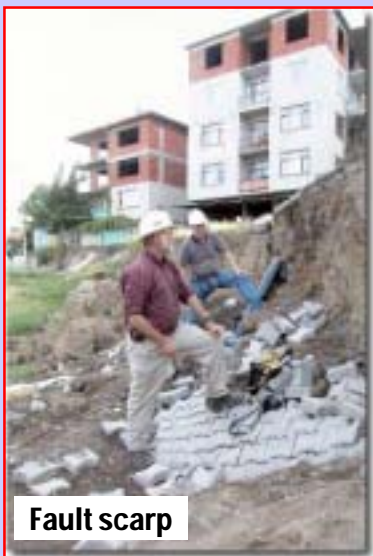
Fault scarp

Kocaeli Earthquake, 1999 Turkey

- Moment magnitude = 7.4
- Focal depth = 17 km
- Rupture along the North Anatolian fault (170 km)
- Right lateral strike slip fault and its secondary normal fault appeared on the ground
- Huge area subsided due to normal faulting
- Average slip along fault length = 3.5 m

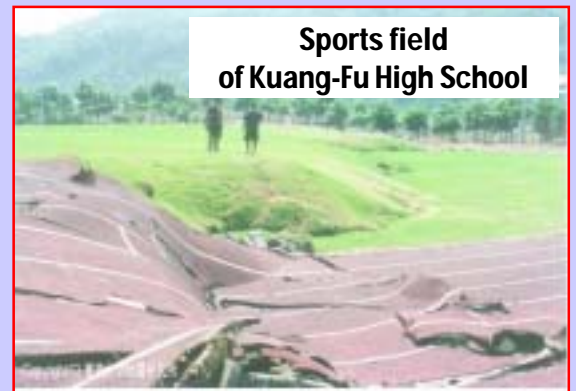
Sports field
of Kuang-Fu High School

Chi-Chi Earthquake, 1999 Taiwan

- Moment magnitude = 7.5
- Focal depth = 6 km
- Rupture along the Cher-Lung-Pu fault (80 km)
- Fault scarp 2-3 m at South and 4-8 m at North
- Irreparable damage caused due to reverse faulting
- Damage was mainly because of differential ground displacement
- New technical issue regarding infrastructure vs surface fault displacement
