PP-BAND RETROFITTING ASSESSMENT - FULL SCALE SHAKING TABLE TESTS (1) -

安価な材料を用いた効果的な耐震補強法の研究
- PPバンドメッシュで補強した組積造建造物の振動台実験(1) -

PP-BAND RETROFITTING ASSESSMENT - FULL SCALE SHAKING TABLE TESTS (2) -

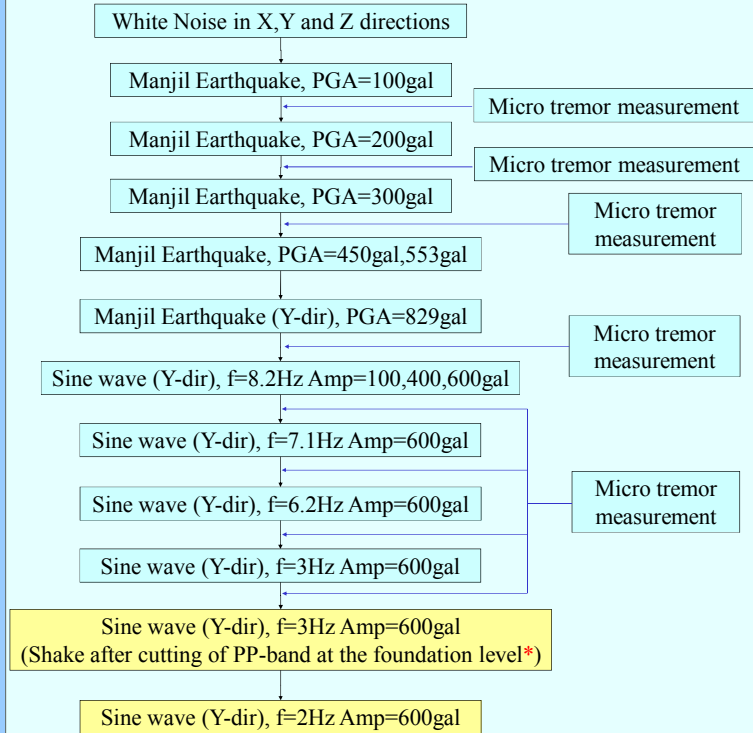
Input Sequence – Brick models

Light blue box: Loading steps for both non-retrofitted and retrofitted house
Yellow box: Loading steps for retrofitted model after non-retrofitted house collapse

* To simulate possible worst case scenario in field if PP-band meshes not connected to foundation level.

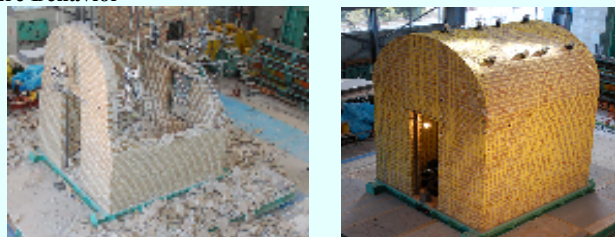
Failure Behavior

Input motion: Manjil Earthquake (scaled for 200 gal)

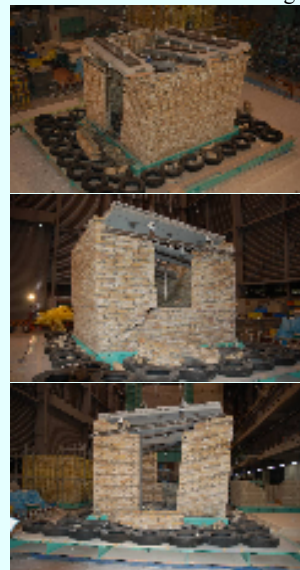
Non-retrofitted -Brick building

Input motion: Sinusoidal wave, $f=3\text{ Hz}$, Amp=600 Gal, 60s
